CITY OF BALTIMORE SMOKE TESTING OBSERVATION SUMMARY JONES FALLS SEWERSHED

BALTIMORE CITY PROJECT 994 REI/DRAYCO

Unique Test ID: 366	Date: 06/12/2008	Basin: JF-19
Defect No: OB01	Supervisor: E.R.	Dye Test Recommended: N
House No: 703	Street Name: E. 20TH	Street Type: ST.
Source Type: 16	Location: 12	Severity: 03

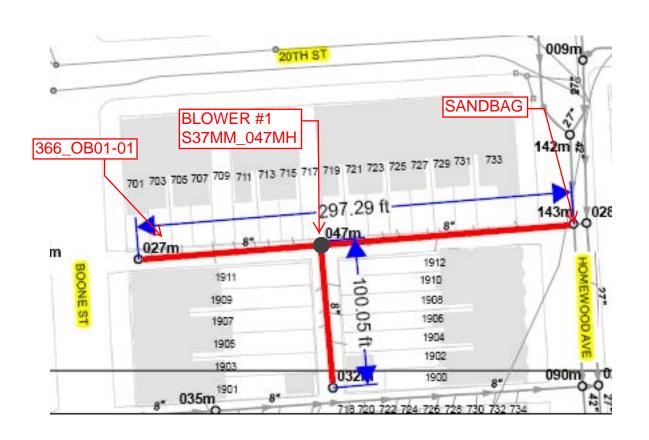
Field Sketch: (Show All Manholes with Numbers, Blower Placement Location, Sandbag or Isolation Locations, Street Names, Building Addresses and Locations, Defect Locations and Photograph Numbers)

TOTAL: 397.3 LF

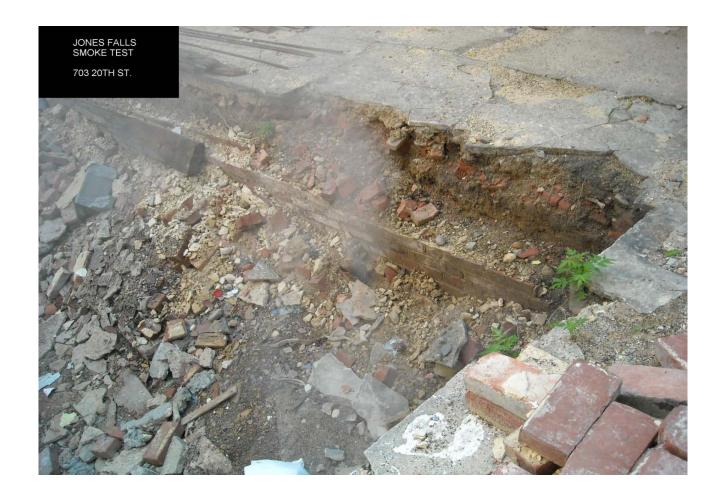
Photograph No: OB01-01 Filename: 0994-366_OB01-01.jpg

Comments: SMOKE COMING FROM MANMADE HOLE IN GROUND AT WORKSITE IN ALLEY BEHIND

ADDRESS.
